Upgrade to Bird Prevention to a Building in Oxford

Location: Kidlington, Oxford
Structure: New Building

Problem: Bird Prevention
Solution: Bird Netting

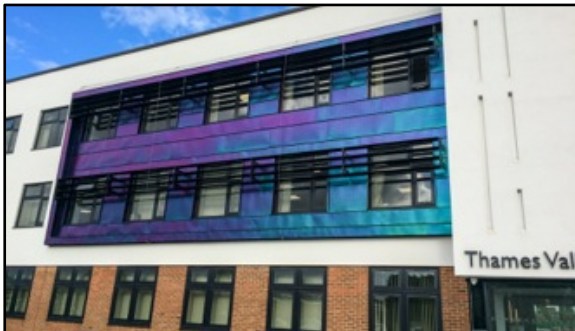
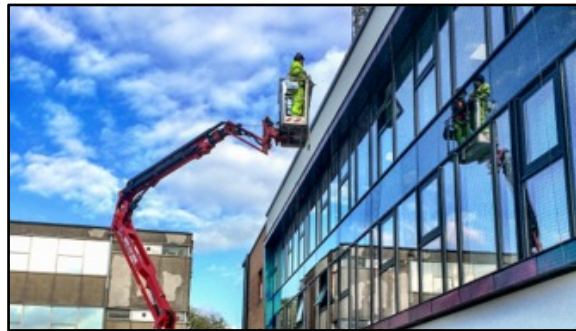
Over the last year or so, pigeons in particular have focused their nightly activities not on the ledges, but inside the Brise Soleil louvers fitted around the buildings and the wide ledges where curved glass windows have been installed using Rimex surface coatings. Bird fouling and in some cases nesting activities had created an unacceptable problem in terms of maintenance and cleaning.

Having studied the situation Rapid ESL proposed the use of bird netting to fully encapsulate the areas in question, utilizing ultra thin netting so as not to distract from the look of the building. Extensive cleaning and removal of the old system in certain areas was a key element in resolving this problem.

When installing netting, the first task is to install a framework of wires to attach the netting to. These are installed in a grid system and the cables tensioned to prevent sagging. Once the framework is fitted, the netting can be installed and pulled to the correct tension, then fixed with hog rings.

Once in position, the netting is checked to make sure no birds are trapped inside.
