Cleaning and Bird Proofing Shaldon Bridge in Devon

Location: Shaldon Bridge Devon
Structure: Bridge over water

Problem: Pigeon Prevention
Solution: Weld Mesh Sheets

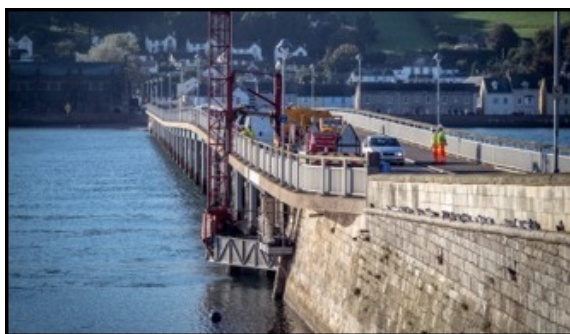
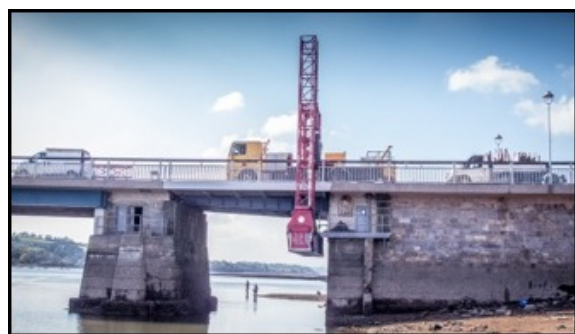
The bridge lends itself to weld mesh as the beams are ideal to clamp the sheets to, allowing us to create an inner and outer cage with a maximum clearance of 25mm so the bridge top and bottom would separate and re-join easily when the bridge is activated.
