Extreme Clean of a church belfry in Witney, Oxfordshire

Structure: Church Belfry

Solution: Extreme Clean

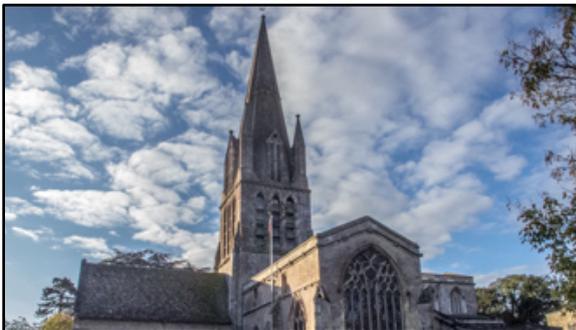
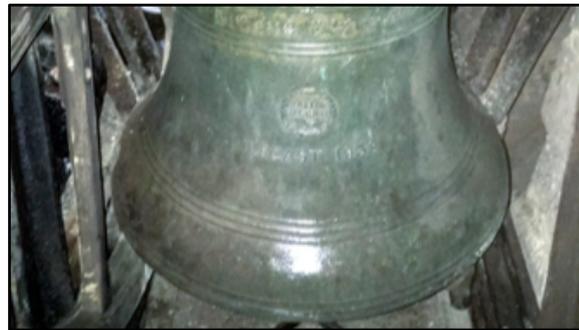
The building has had some bird prevention installed quite a few years ago, but over time holes have appeared and allowed birds to enter the belfry. Once inside, nesting materials and tons of droppings and carcasses have been deposited on the bells and their workings below making the environment particularly hazardous for repairs and servicing to be carried out on the clocks.

All the birds were trapped and removed from the area and the holes sealed up to prevent further ingress before the cleaning could start.

The bird fouling was then pre-treated with a powerful pathogen killing fluid designed especially for removal and decontaminating of bird guano. This also helps breakdown the faeces and allows cleaning to take place more effectively. Once the chemicals had started to work, the bells could be cleaned and made safe.

The project took 3 days to complete which was expected due to the amount of guano and debris to clean up as well as completely cleaning 8 huge bells and all the intricate mechanisms, but the end result was superb.
