# Pigeon Proofing of a Shopping Centre

Location: Guildford

Structure: Shopping Centre

Solution: Bird Netting

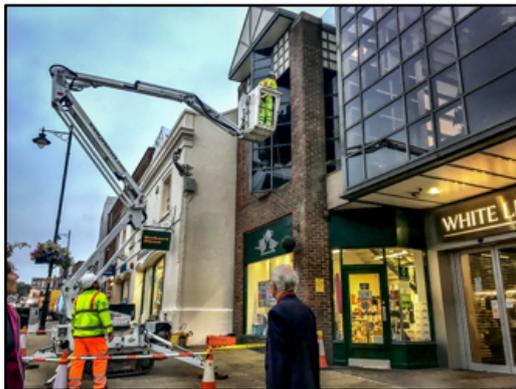
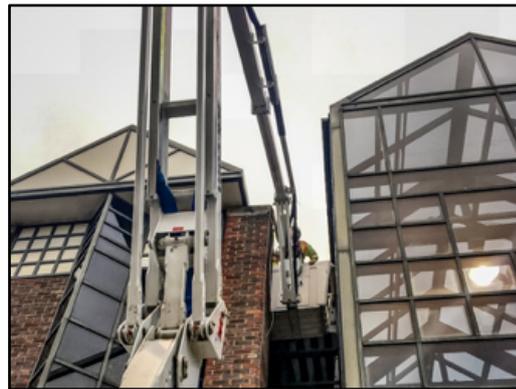
Despite many attempts to proof this structure, pigeons have still managed to gain access to the areas, mostly due to poor netting practices. Pigeons were also getting trapped behind the existing netting causing unnecessary suffering and complaints from the public. It also caused constant fouling and slip hazards on the pavements outside the entrances.

Once the old netting and wire has been removed we installed a new netting framework to which the netting is fixed. Bird spikes were installed to stop any roosting on high ledges to prevent any fouling below.

Once the nets were fitted, we installed our own specially designed bird outlets, which allow birds to escape from the netting structure in the event of a breach in the net in the future.
