# Bird proofing for a brand new railway bridge in London

Location: Croydon

Structure: Network Rail Bridge

Solution: Weld Mesh Sheeting

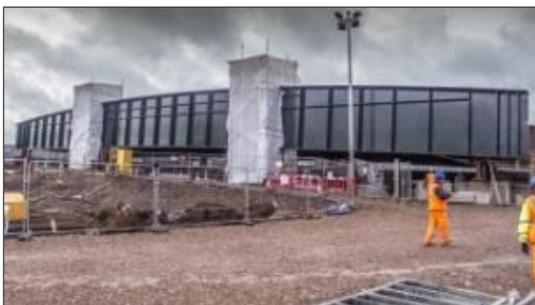
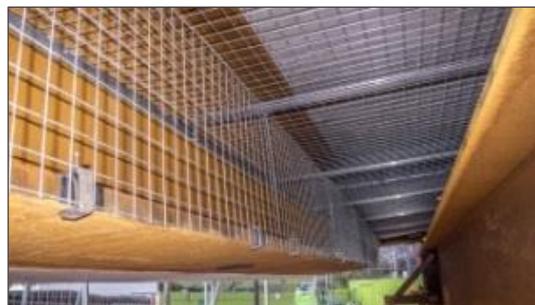
This particular solution was based upon weld mesh sheeting being installed to prevent the birds gaining access to the underside of the bridges and beams. Weld mesh is fast becoming the standard media for bird proofing bridges and other public structures where traditional nylon netting has been used and damaged allowing birds back in. On a structure like this, once in place a possession order to work on the railway lines would be difficult to obtain, so it had to be done once and only once, so weldmesh was the only choice.

Specially designed clamps were used to ensure the mesh, once positioned, would be permanently fixed, with the threads locked using thread adhesive to prevent shaking and vibrations working them loose. Further vibration protection was added under the weld mesh and fixings to complete the solution.
